Enhancement of the Fatigue Performance of Ti-6Al-4V Implant Products

**Dematapaksha Hewage
Ruminda Jeewantha Wimalasiri**

**A thesis submitted in partial fulfilment of the requirements of
Sheffield Hallam University
for the degree of Doctor of Philosophy**

January, 2009

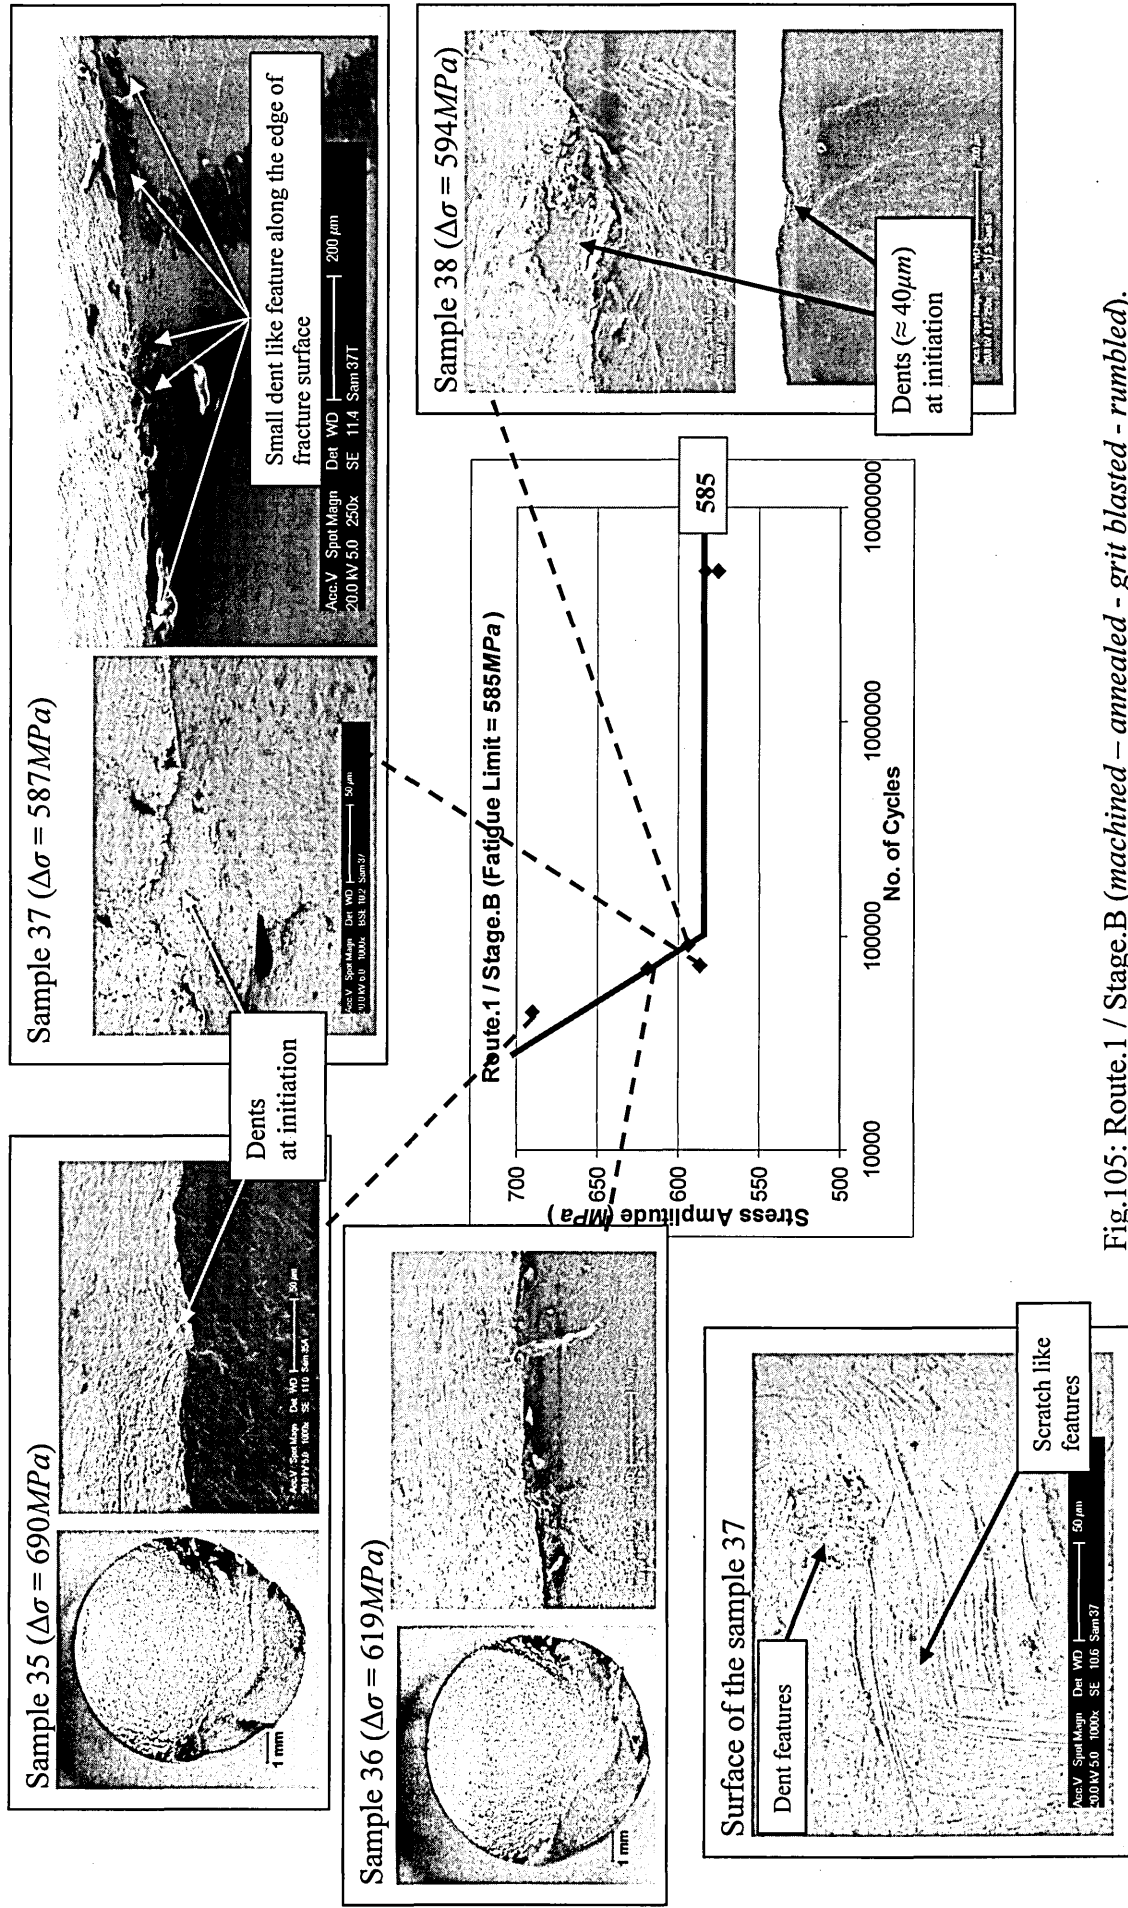
Fig.105: Route.1 / Stage.B (machined – annealed – grit blasted – rumbled).

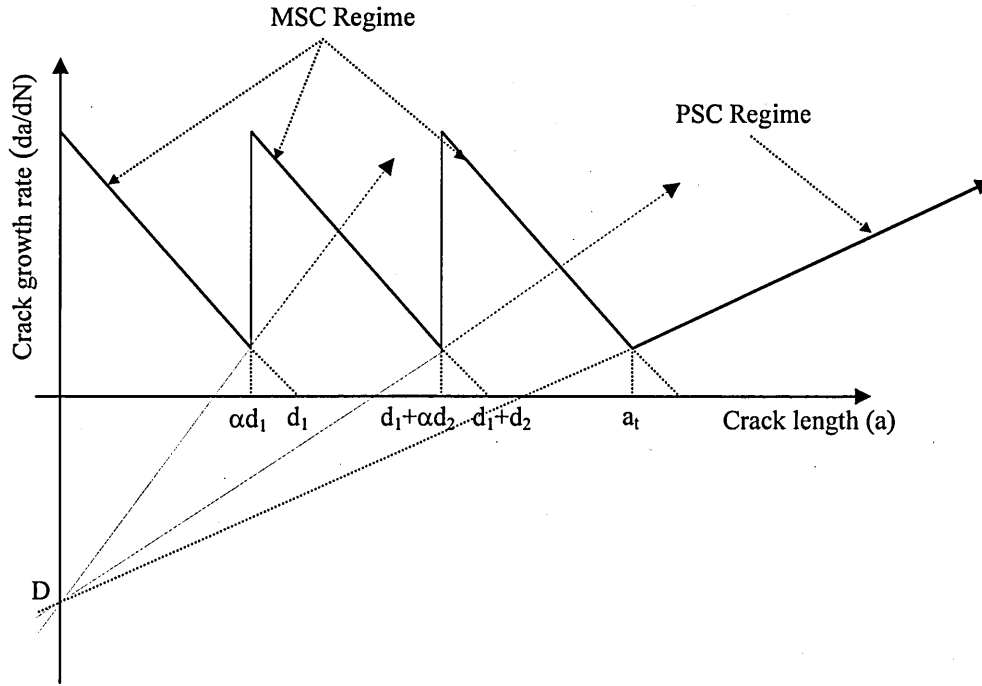
Fig.110: Schematic diagram which represent the MSC and PSC propagation

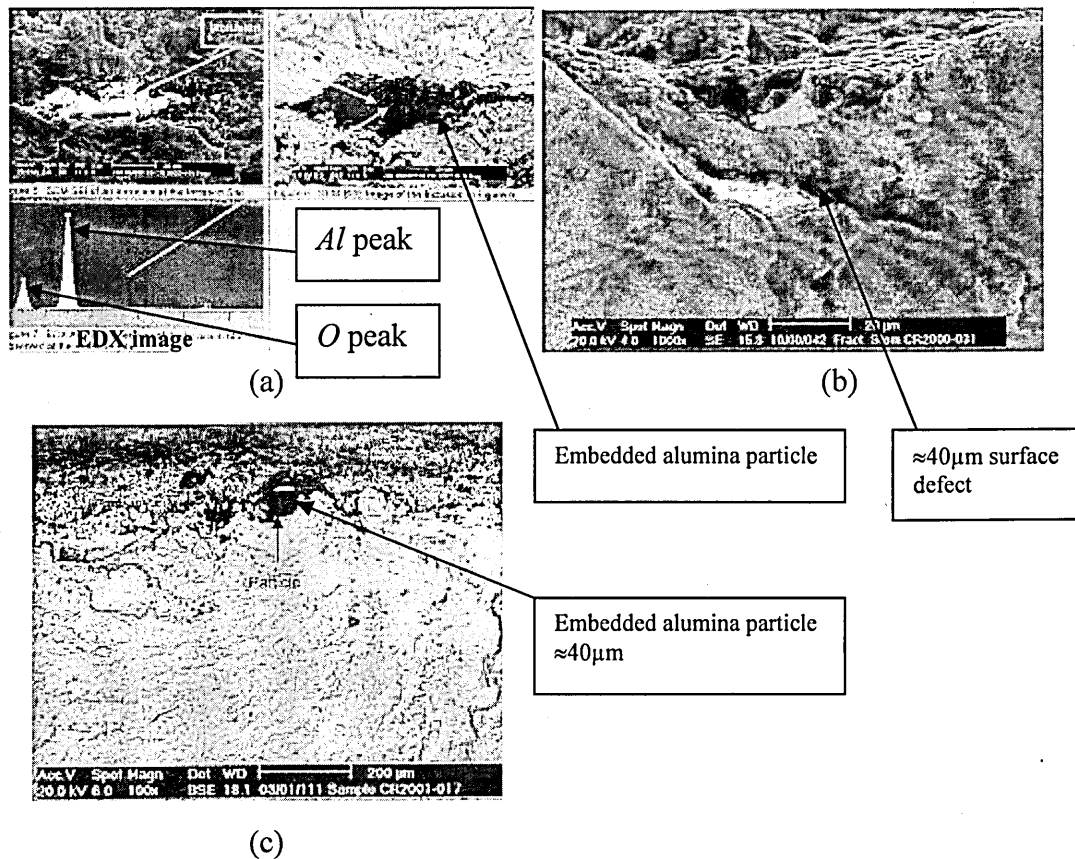
Fig.112 : Initiation features of selected cone failures (a) service life - 1y 6m, (b) service life - 2y, (c) service life - 1y [163].

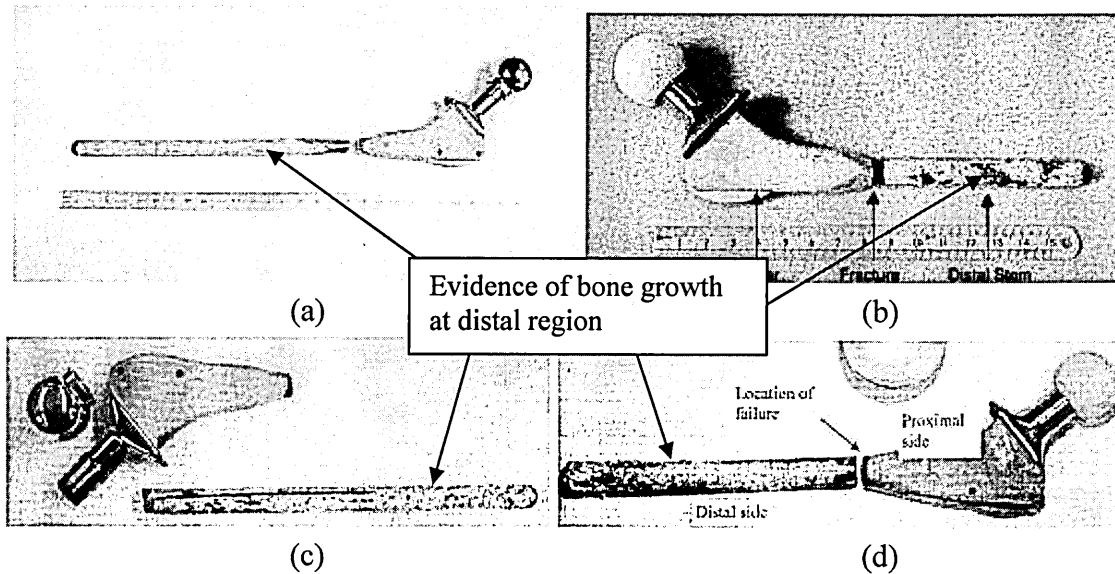
Fig.113 : Integration of the implants with the bone of selected cone failures, evident of little or no bone growth in the proximal region, (a) service life - 2y, (b) service life - 1y, (c) service life - 1y 6m, (d) service life - 1y 2m [163].

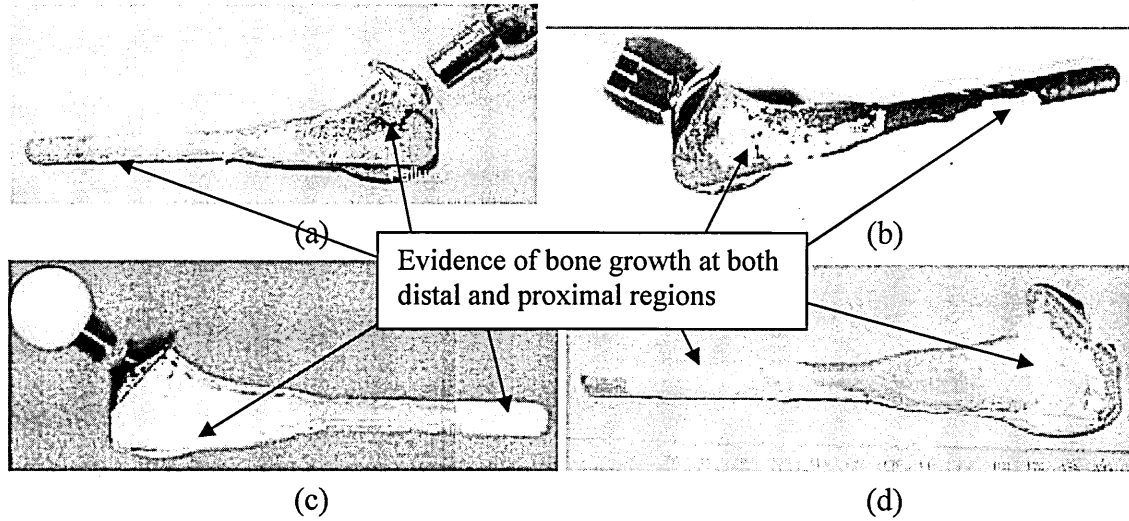
Fig.115: Integration of the implants with the bone of selected neck failures, evidence of firm fixation at the proximal region, (a) service life - 2y, (b) service life - 1y, (c) service life - 1y 6m, (d) service life - 1y 2m [163].

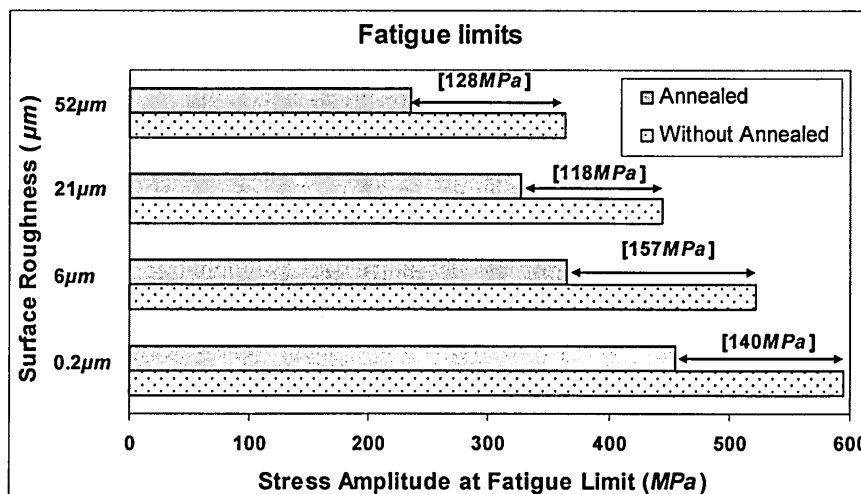
Fig.116: Variation of fatigue limit due to the change of surface residual stress.

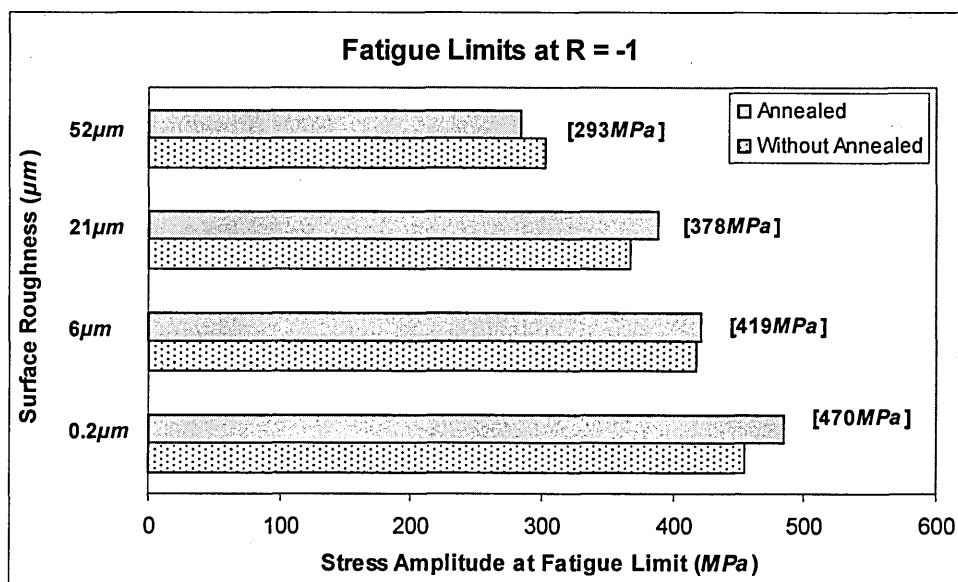
Fig.118: Calculated fatigue limits for $R = -1$. Average fatigue limits of both WA and A condition at each roughness level are noted within square brackets.

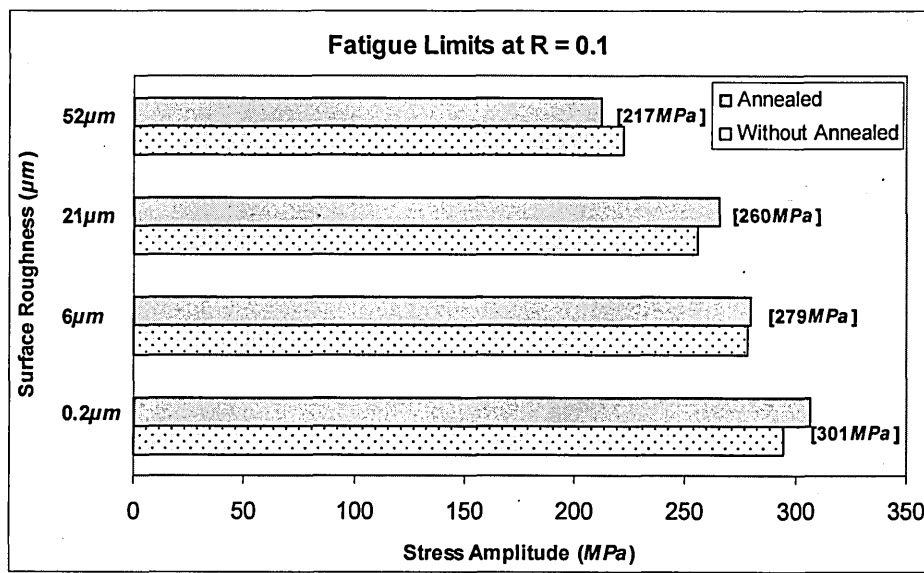
Fig.119: Calculated fatigue limits for $R = 0.1$. Average fatigue limits of both WA and A condition at each roughness level are noted within square brackets.

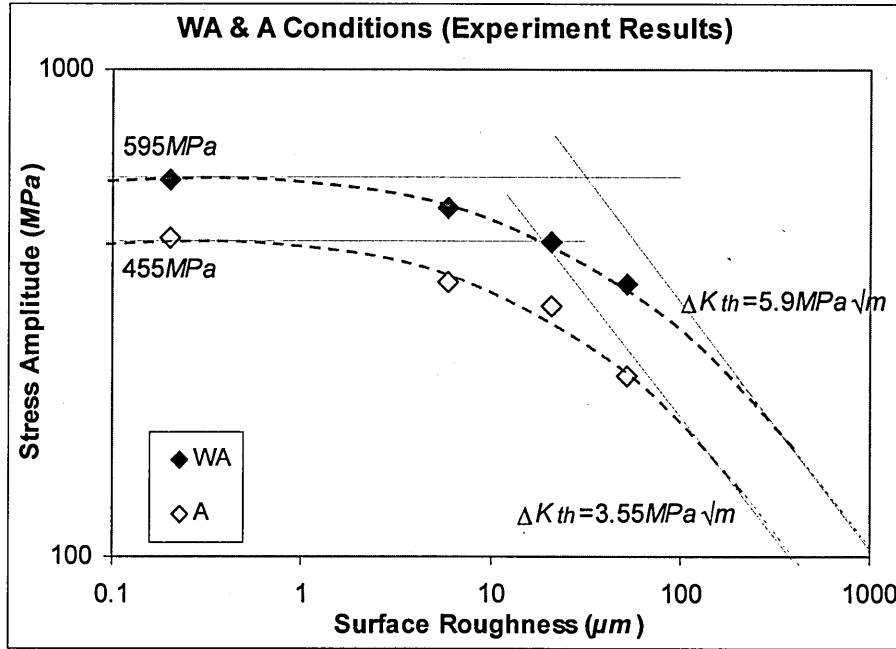
Fig.120: K-T type diagram showing the estimated threshold stresses for *WA* and *A* conditions.

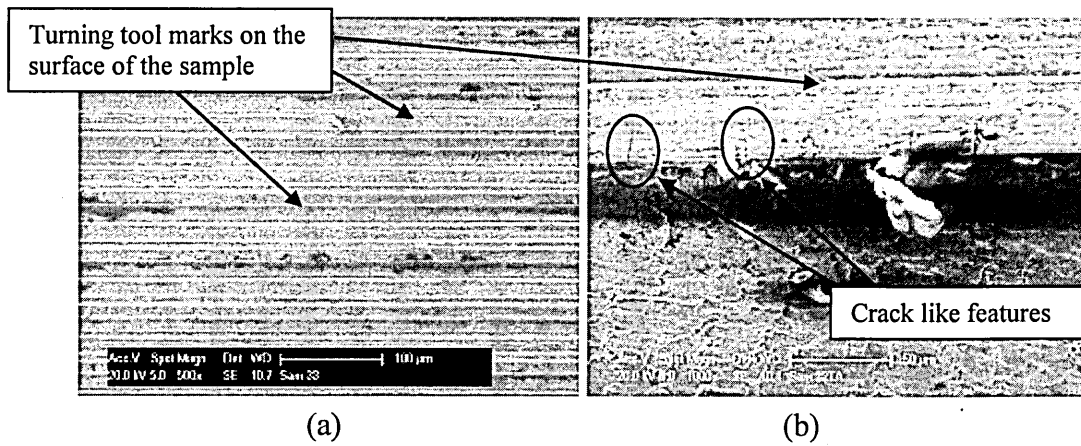
Fig.123: (a) Surface of a sample at Route.1/ Stage.A (Sample No.33), (b) Fatigue initiation region of Sample No.32.

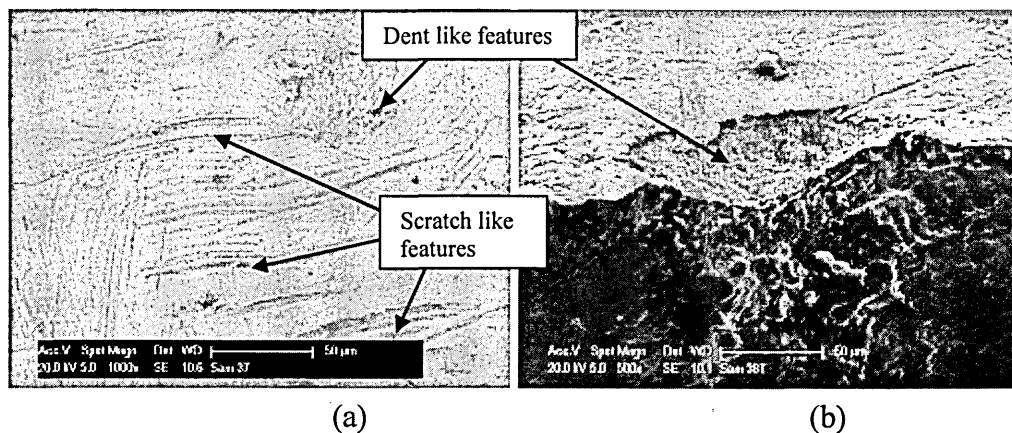
Fig.124: (a) Surface of a sample (Sample No.37) at Route.1, Stage.B, (b) Fatigue initiation region of Sample No.38.

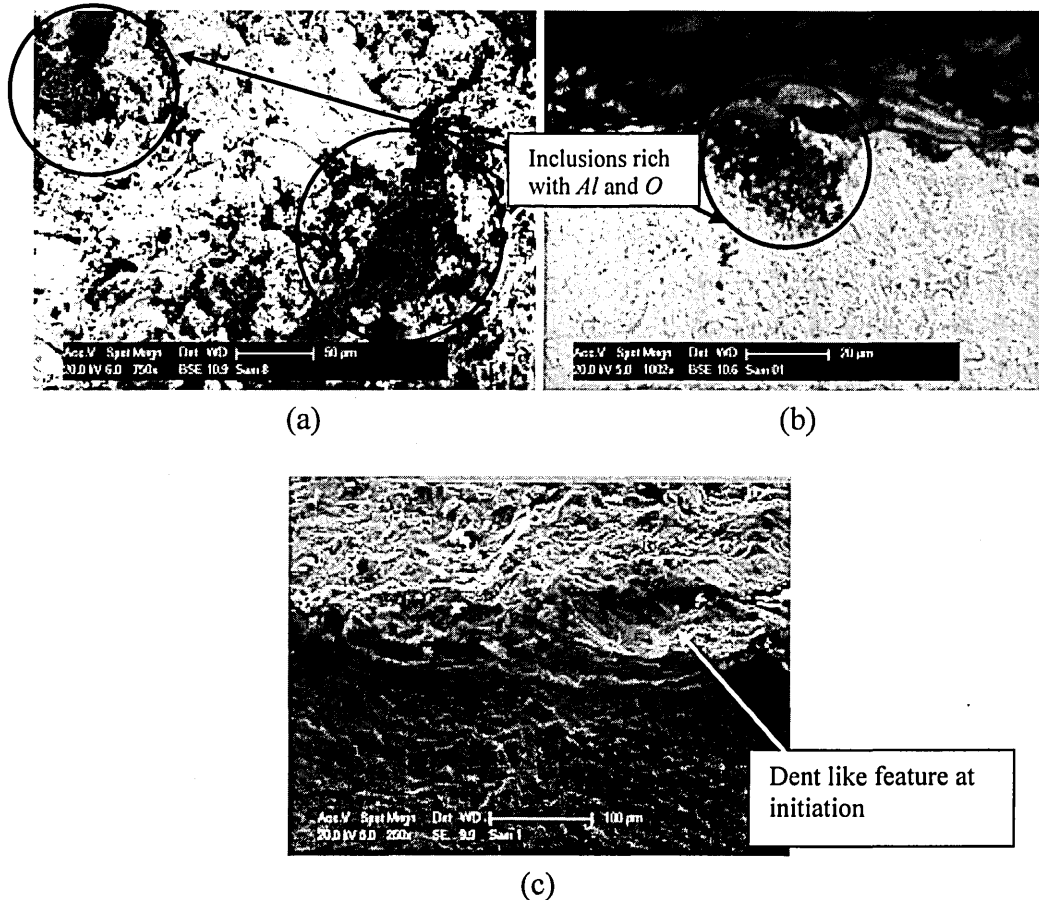
Fig.125: (a) Surface of a sample (Sample No.8) at Route.1, Stage.D/C, (b) Fatigue initiation region of Sample No.1, (c) Defect found at the initiation area of Sample No.7.

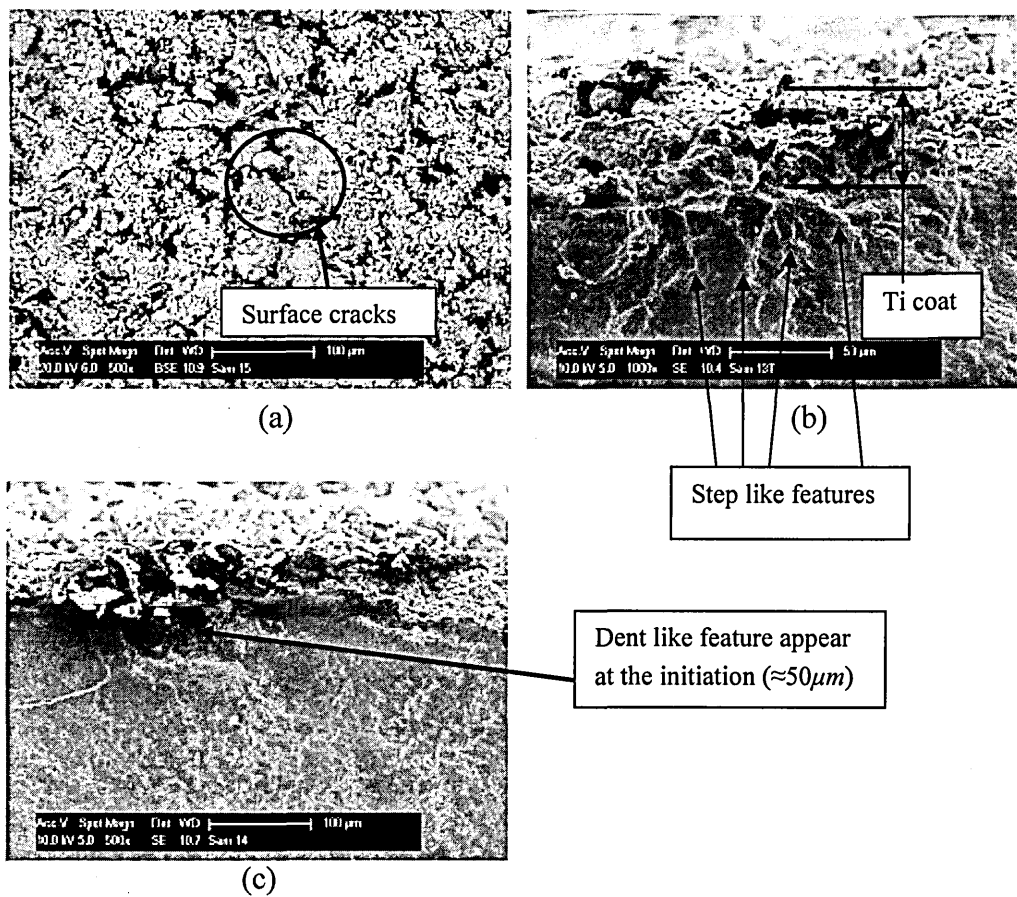
Fig.126: (a) Surface of a sample (Sample No.15) at Route.1, Stage.E, and fatigue initiation regions of samples; (b) Sample No.13, (c) Sample No.14.

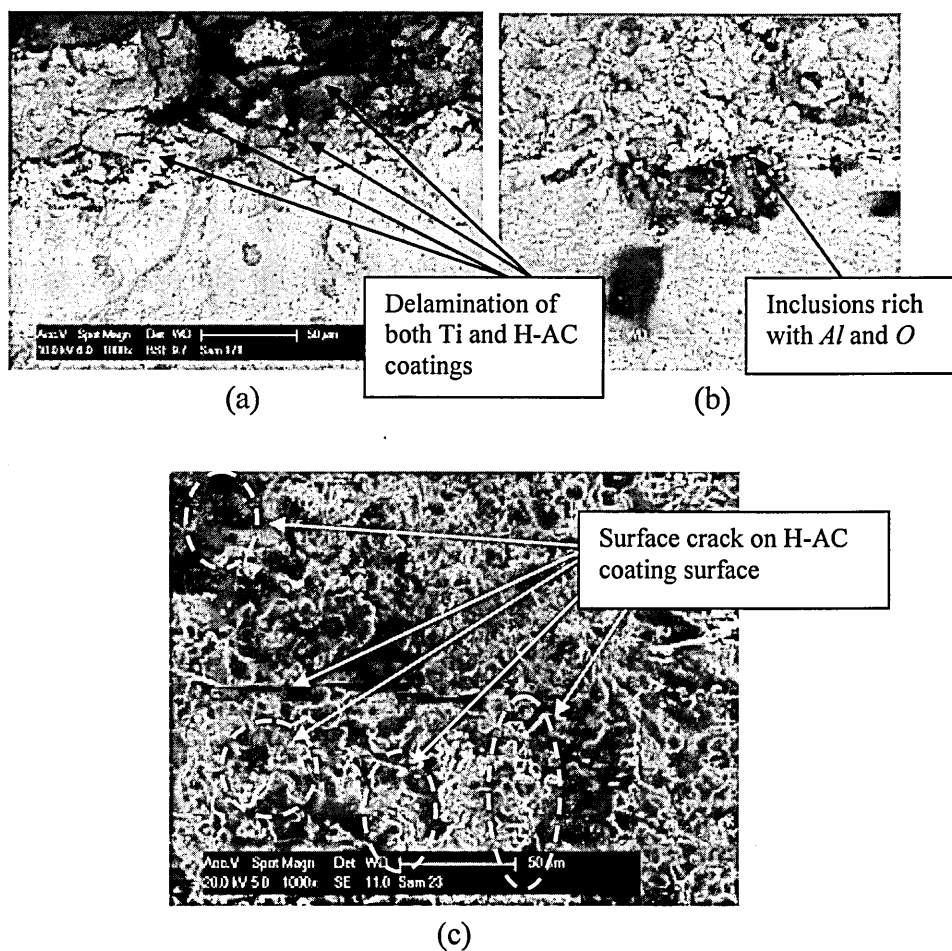
Fig.127: Fatigue initiation region of samples; (a) Sample No.17, (b) Sample No.18 and (c) surface of H-AC coating (Sample No.23)

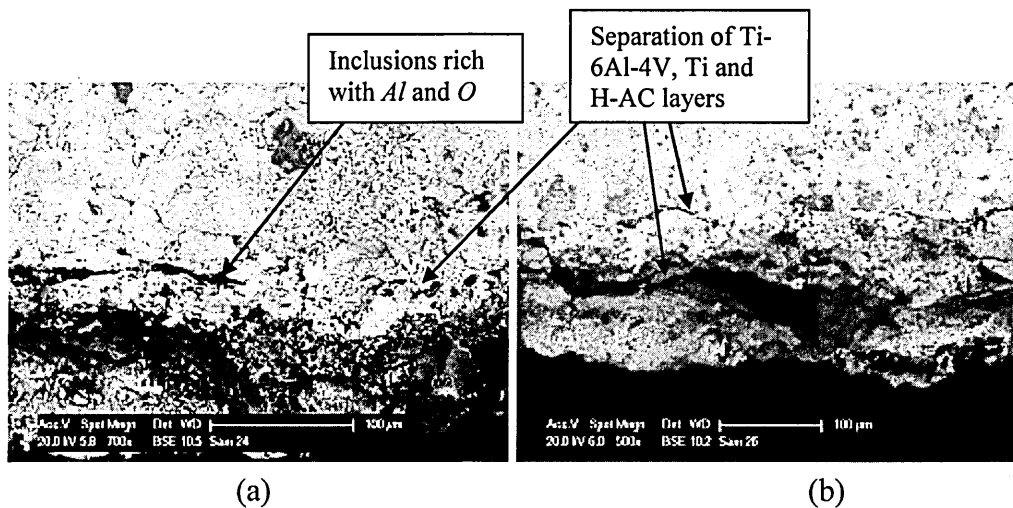
Fig.128: Fatigue initiation region of samples; (a) Sample No.24, (b) Sample No.26.

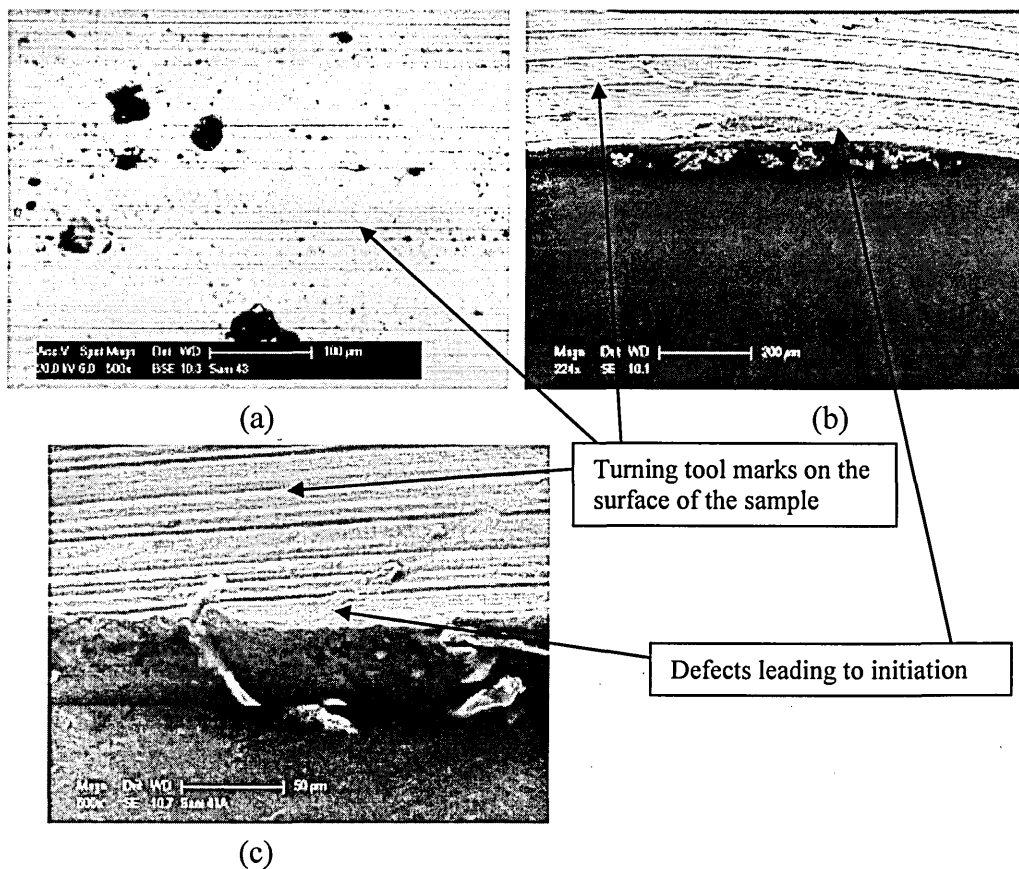
Fig.129: (a) Surface of a sample (Sample No.43) at Route.1, Stage.E, and Fatigue initiation region of samples; (b) Sample No.41, (c) Sample No.40.

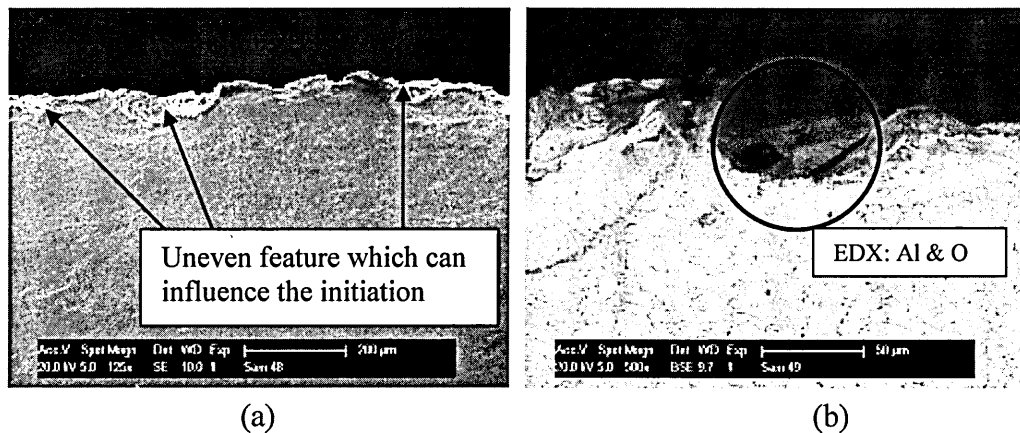
Fig.130: Fatigue initiation region of samples; (a) Sample No.48, (b) Sample No.49.

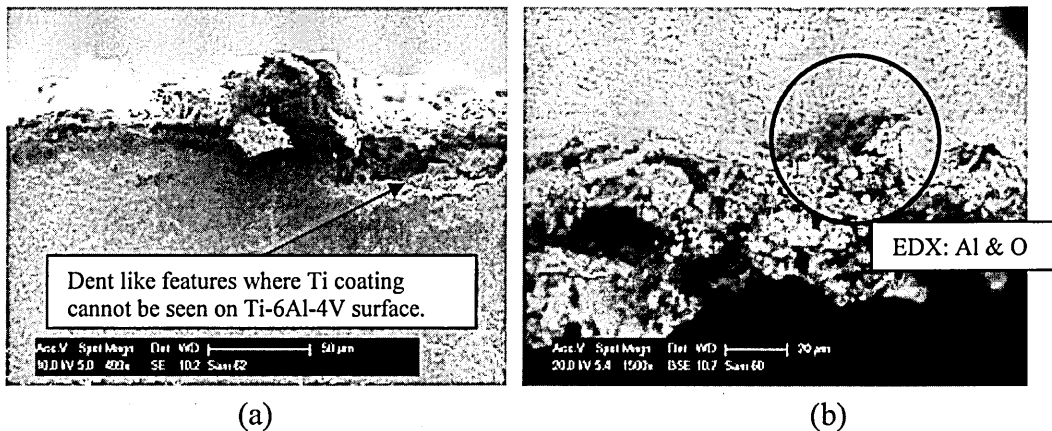
Fig.131: Fatigue initiation region of samples; (a) Sample No.62, (b) Sample No.60.

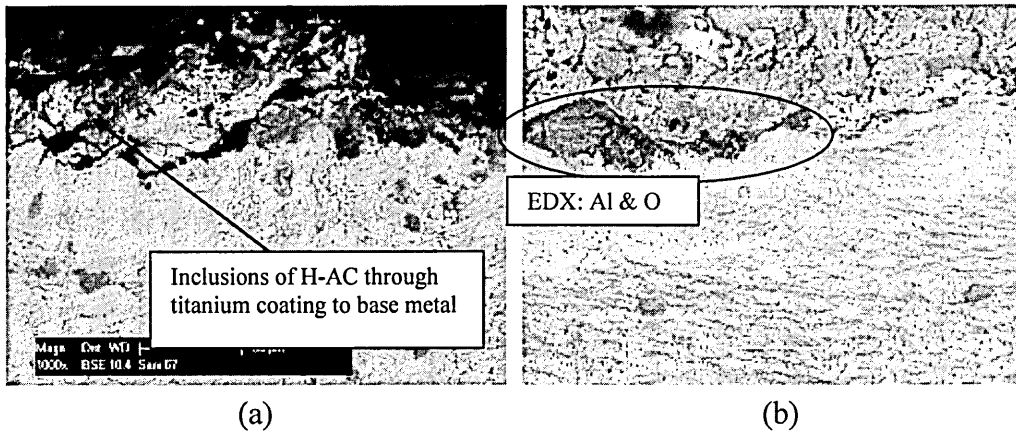
Fig.132: Fatigue initiation region of samples; (a) Sample No.62, (b) Sample No.60.

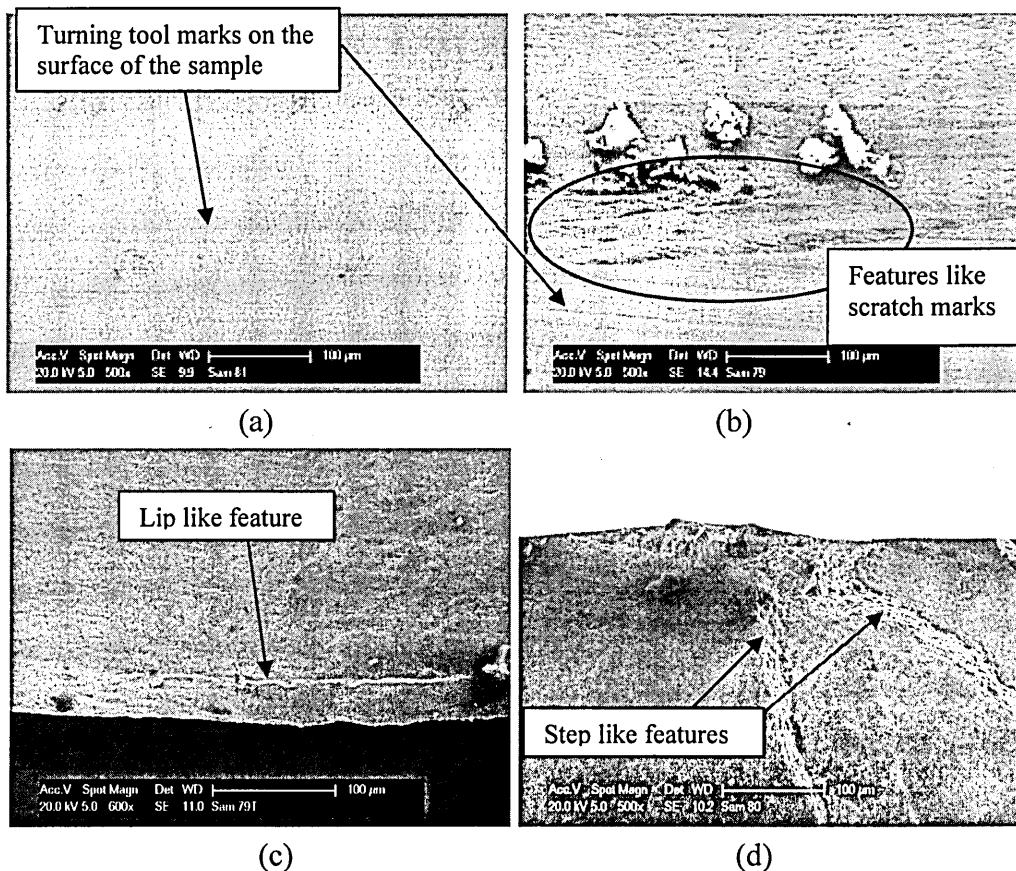
Fig.134: (a) Surface of Sample No.81, and fatigue initiation region of samples; (b) Sample No.79, (c) Sample No.79, (d) Sample No.80.

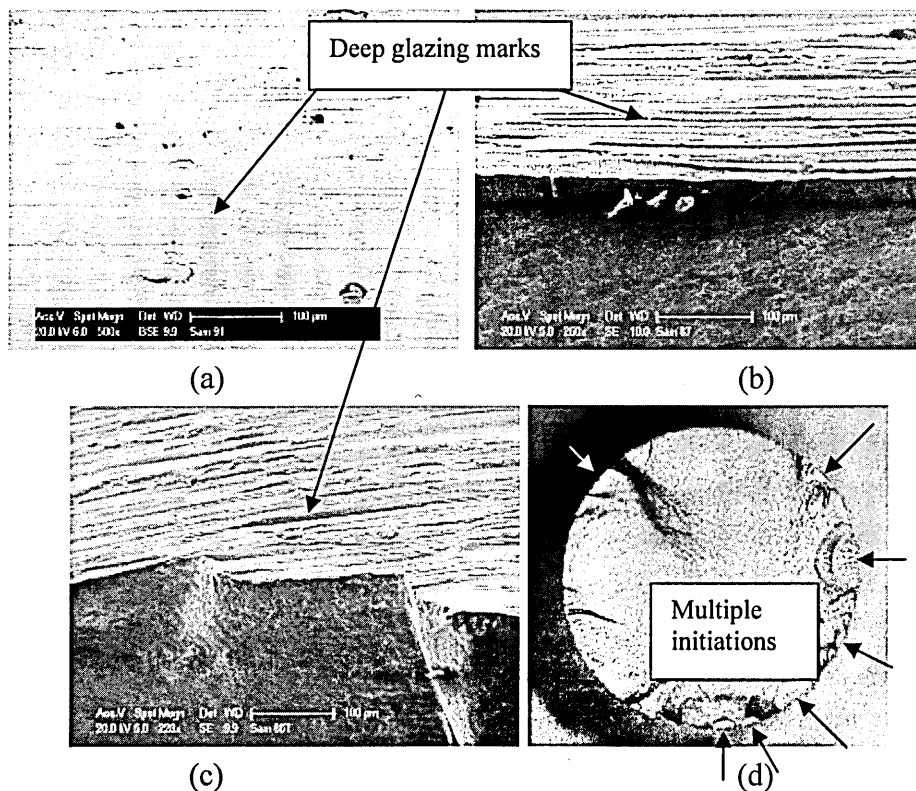
Fig.135: Route.1/Stage.E samples. (a) Surface of Sample No.91, and fatigue initiation region of (b) Sample No.87, (c) Sample No.86, and (d) multiple initiation sites of Sample No.85.

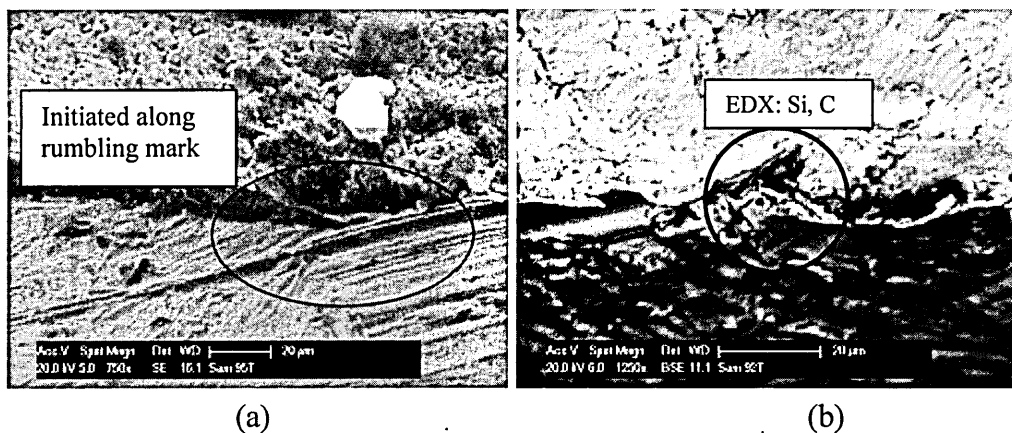
Fig.136: (a) Fatigue initiation region of a failed sample (Sample No.95), (b) Fatigue initiation region of a failed sample (Sample No.92).

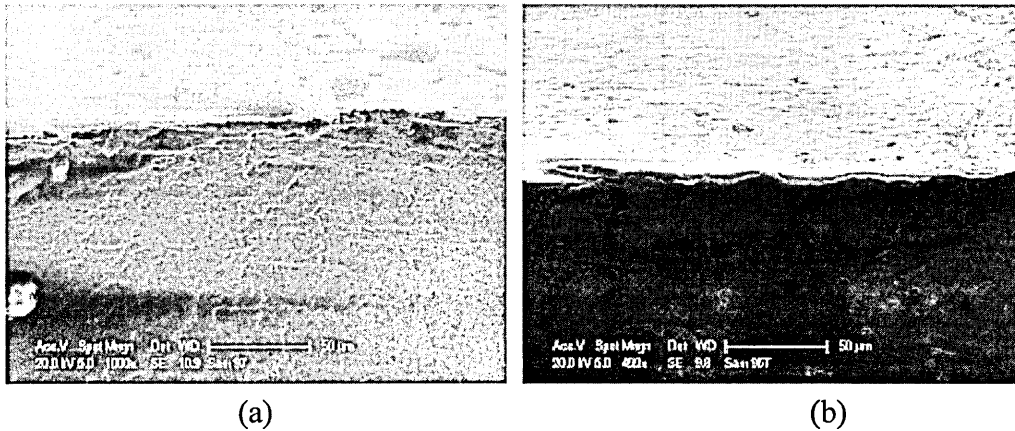
Fig.137: Fatigue initiation region of sample; (a) Sample No.97, (b) Sample No.96.

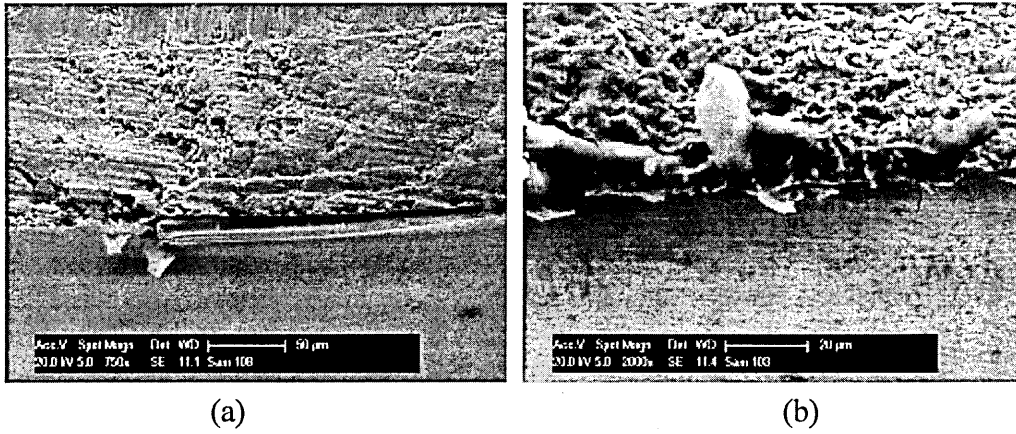
Fig.138: Fatigue initiation region of samples; (a) Sample No.108, (b) Sample No.103.

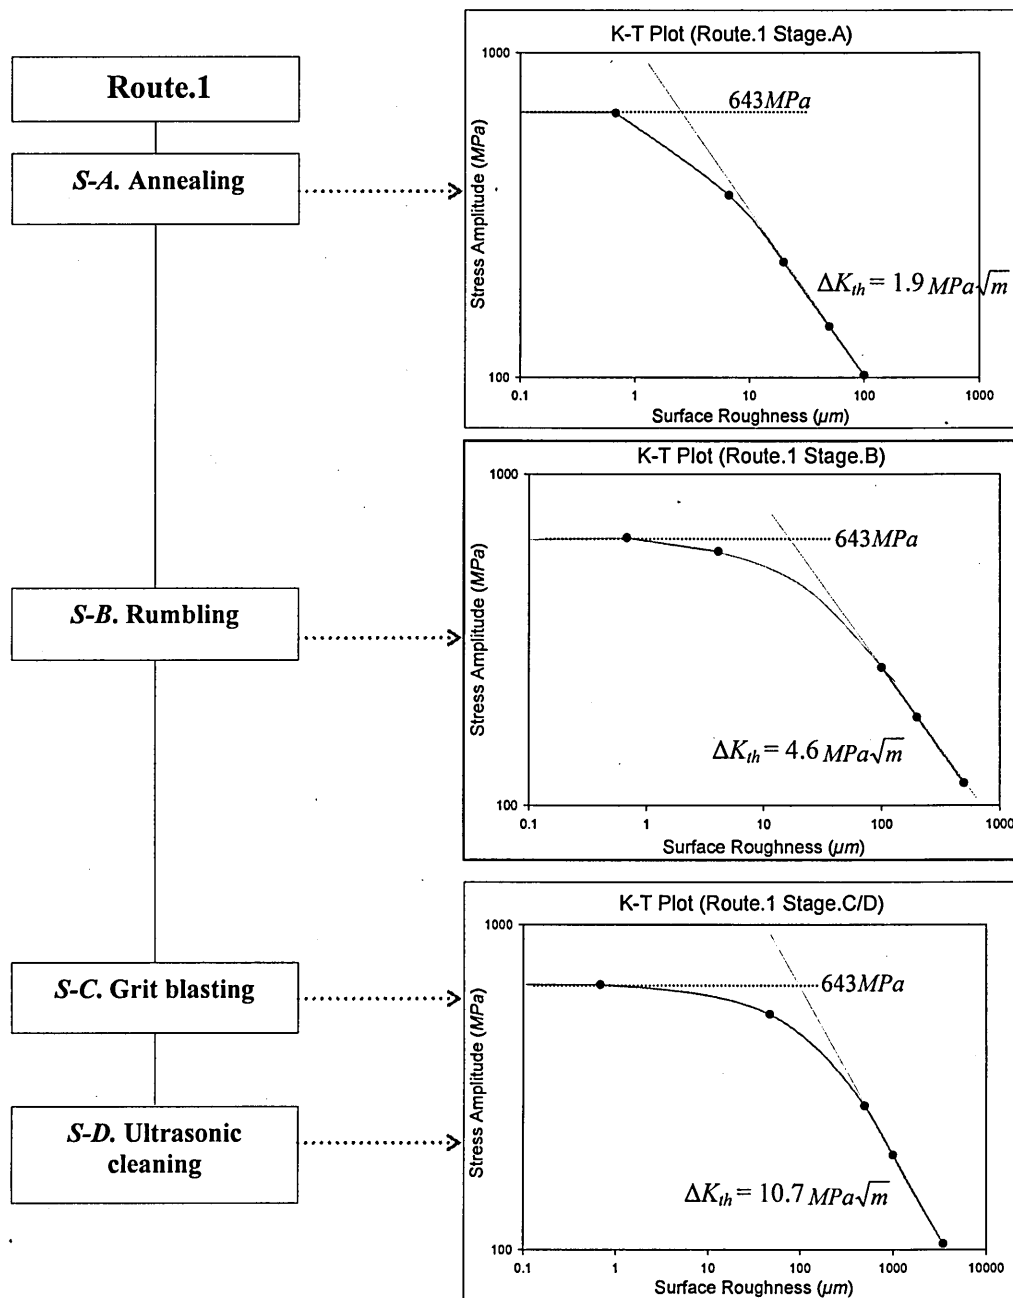
Fig.139: K-T Plots of Route.1 Stage A, B, C and D.

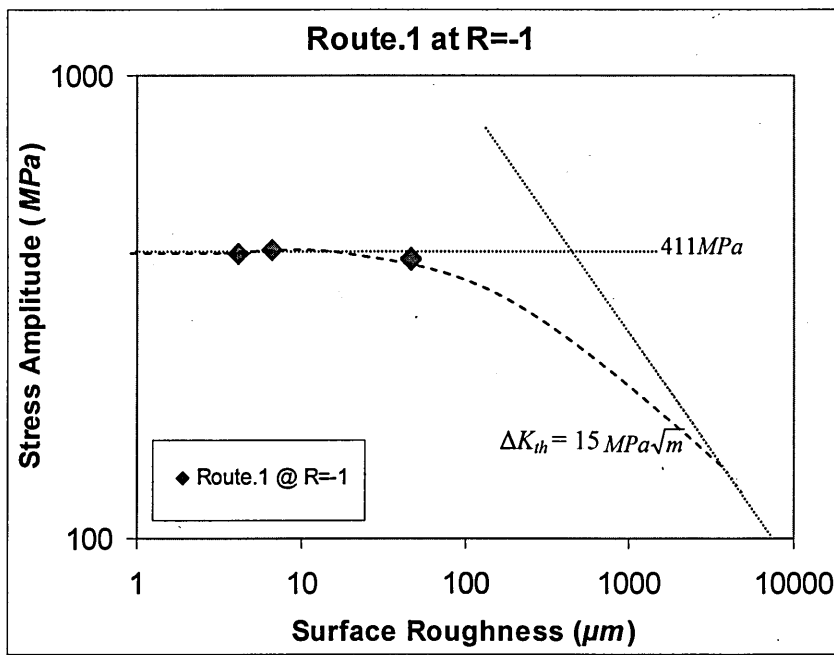
Fig.140: K-T Plot for Route.1 at $R = -1$.

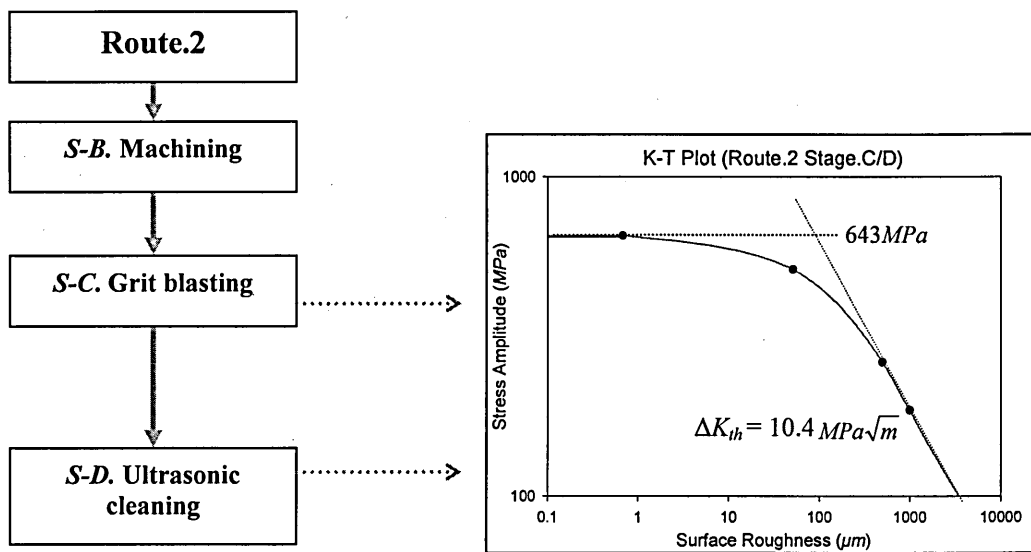
Fig.141: K-T Plots of Route.2 Stage C and D.

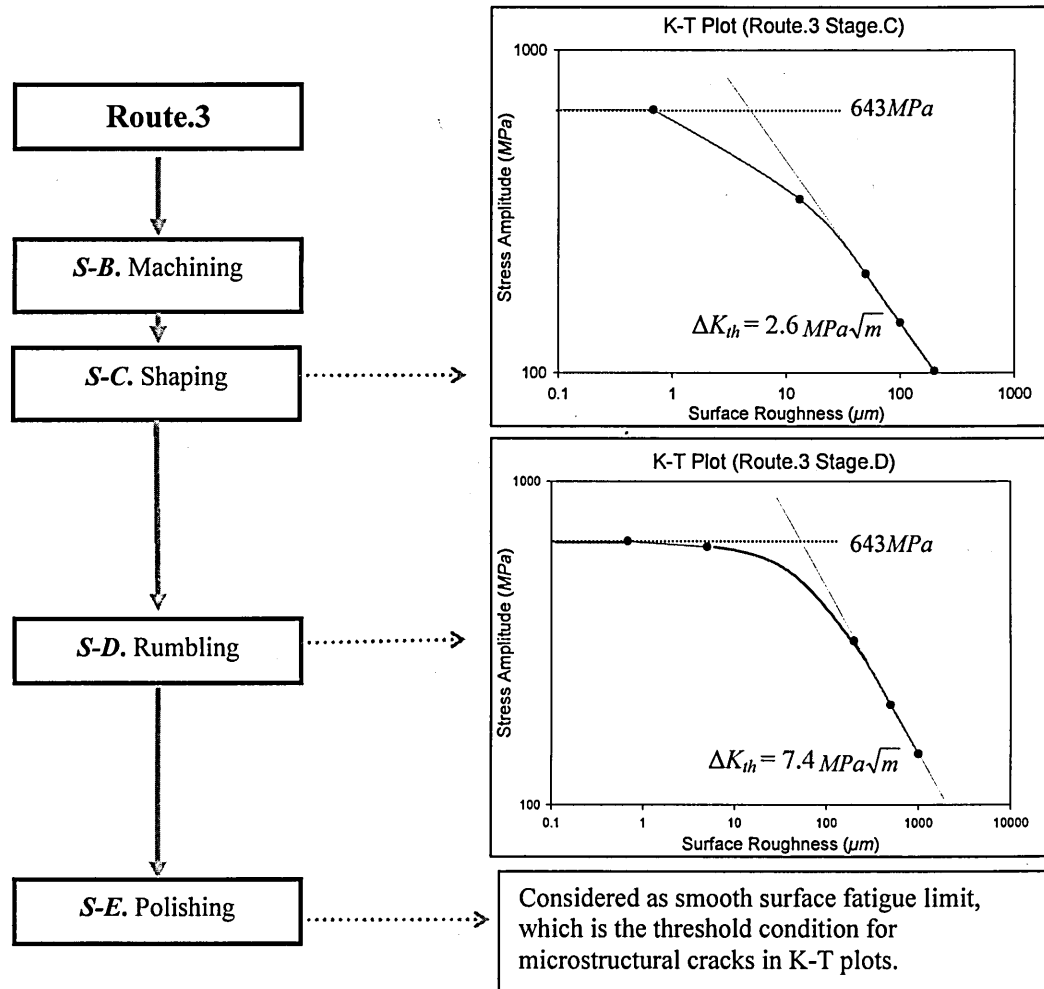
Fig.143: K-T Plots of Route.3 Stage C and D.

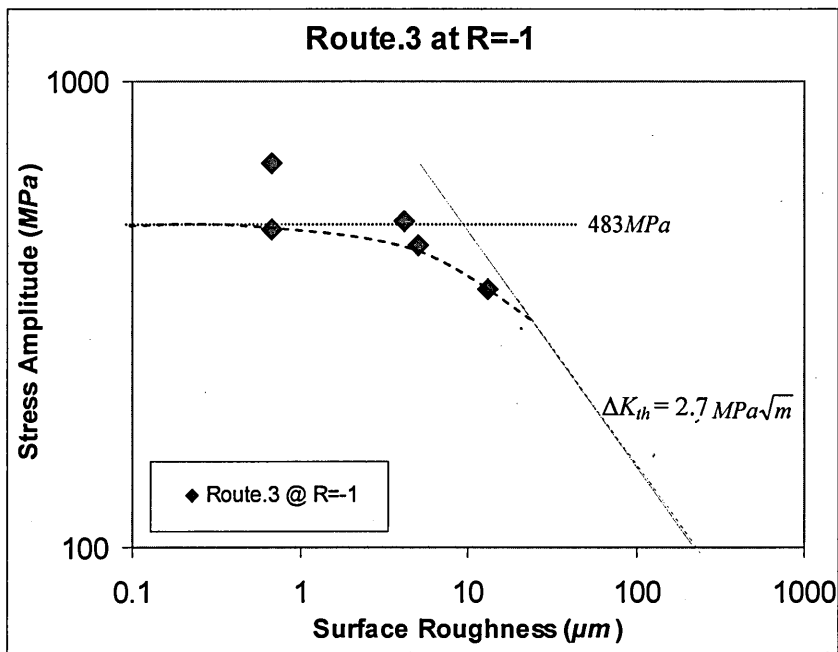
Fig.144: K-T Plot for Route.3 at $R = -1$.

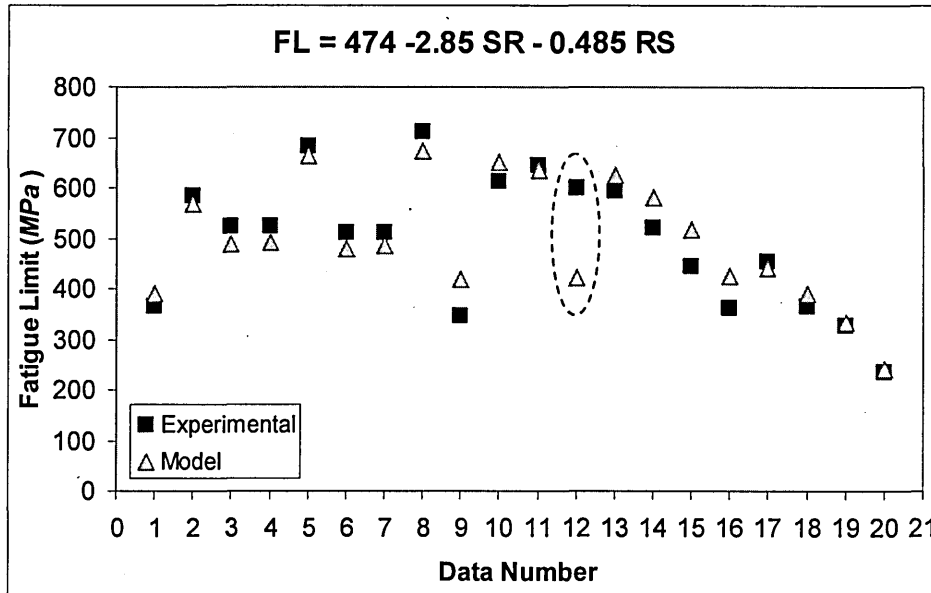
Fig.147: Comparison of the fatigue limit values calculated from derived equation (35) with the experimental results.
